U.S.S. MONITOR

A FINAL REPORT
ON 1979 SITE TESTING IN THE MONITOR NATIONAL MARINE SANCTUARY

BY GORDON P. WATTS, JR.
NORTH CAROLINA DEPARTMENT OF CULTURAL RESOURCES

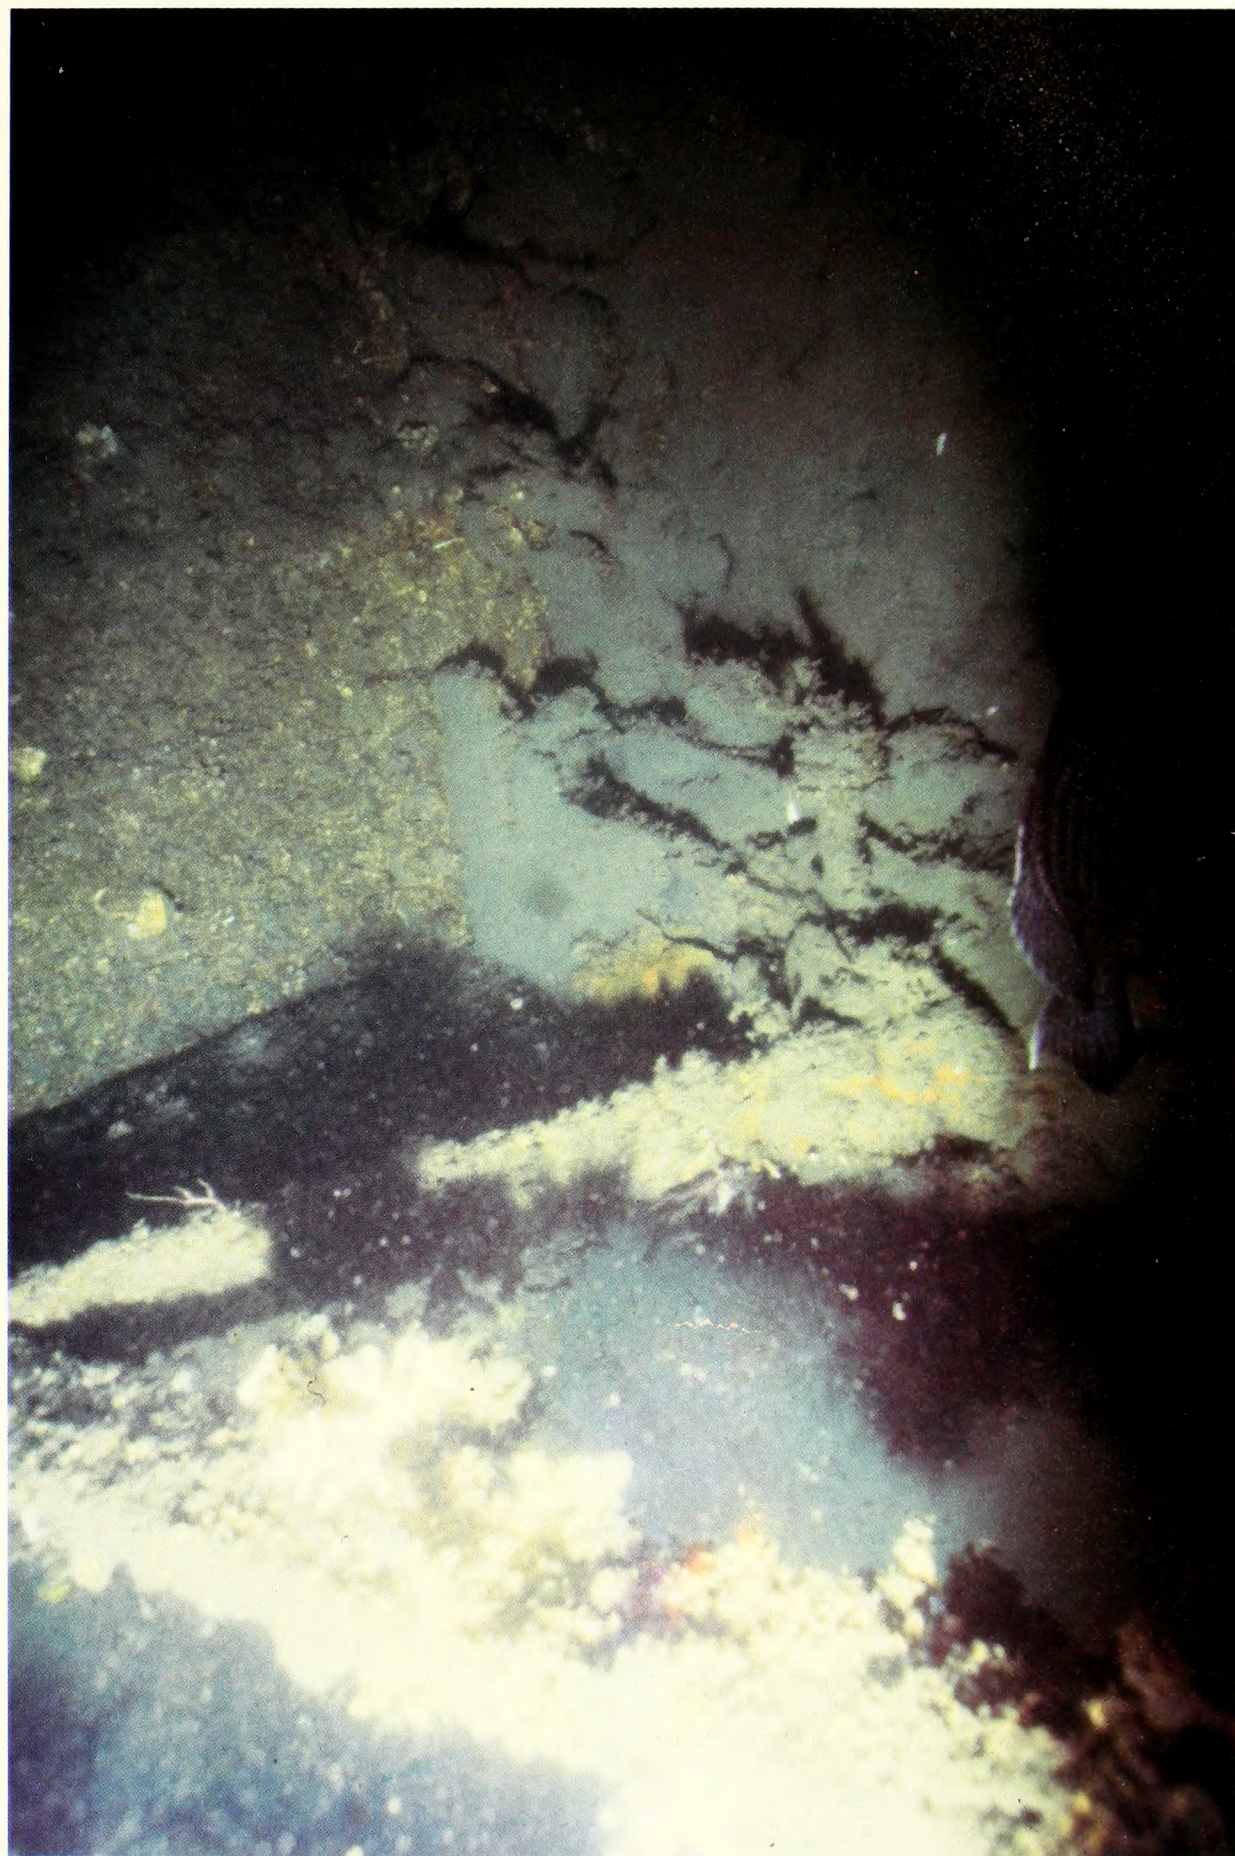
Figure 137. Diagonal bracing inside the port armor belt rests on the deteriorated remains of a wood deck beam.

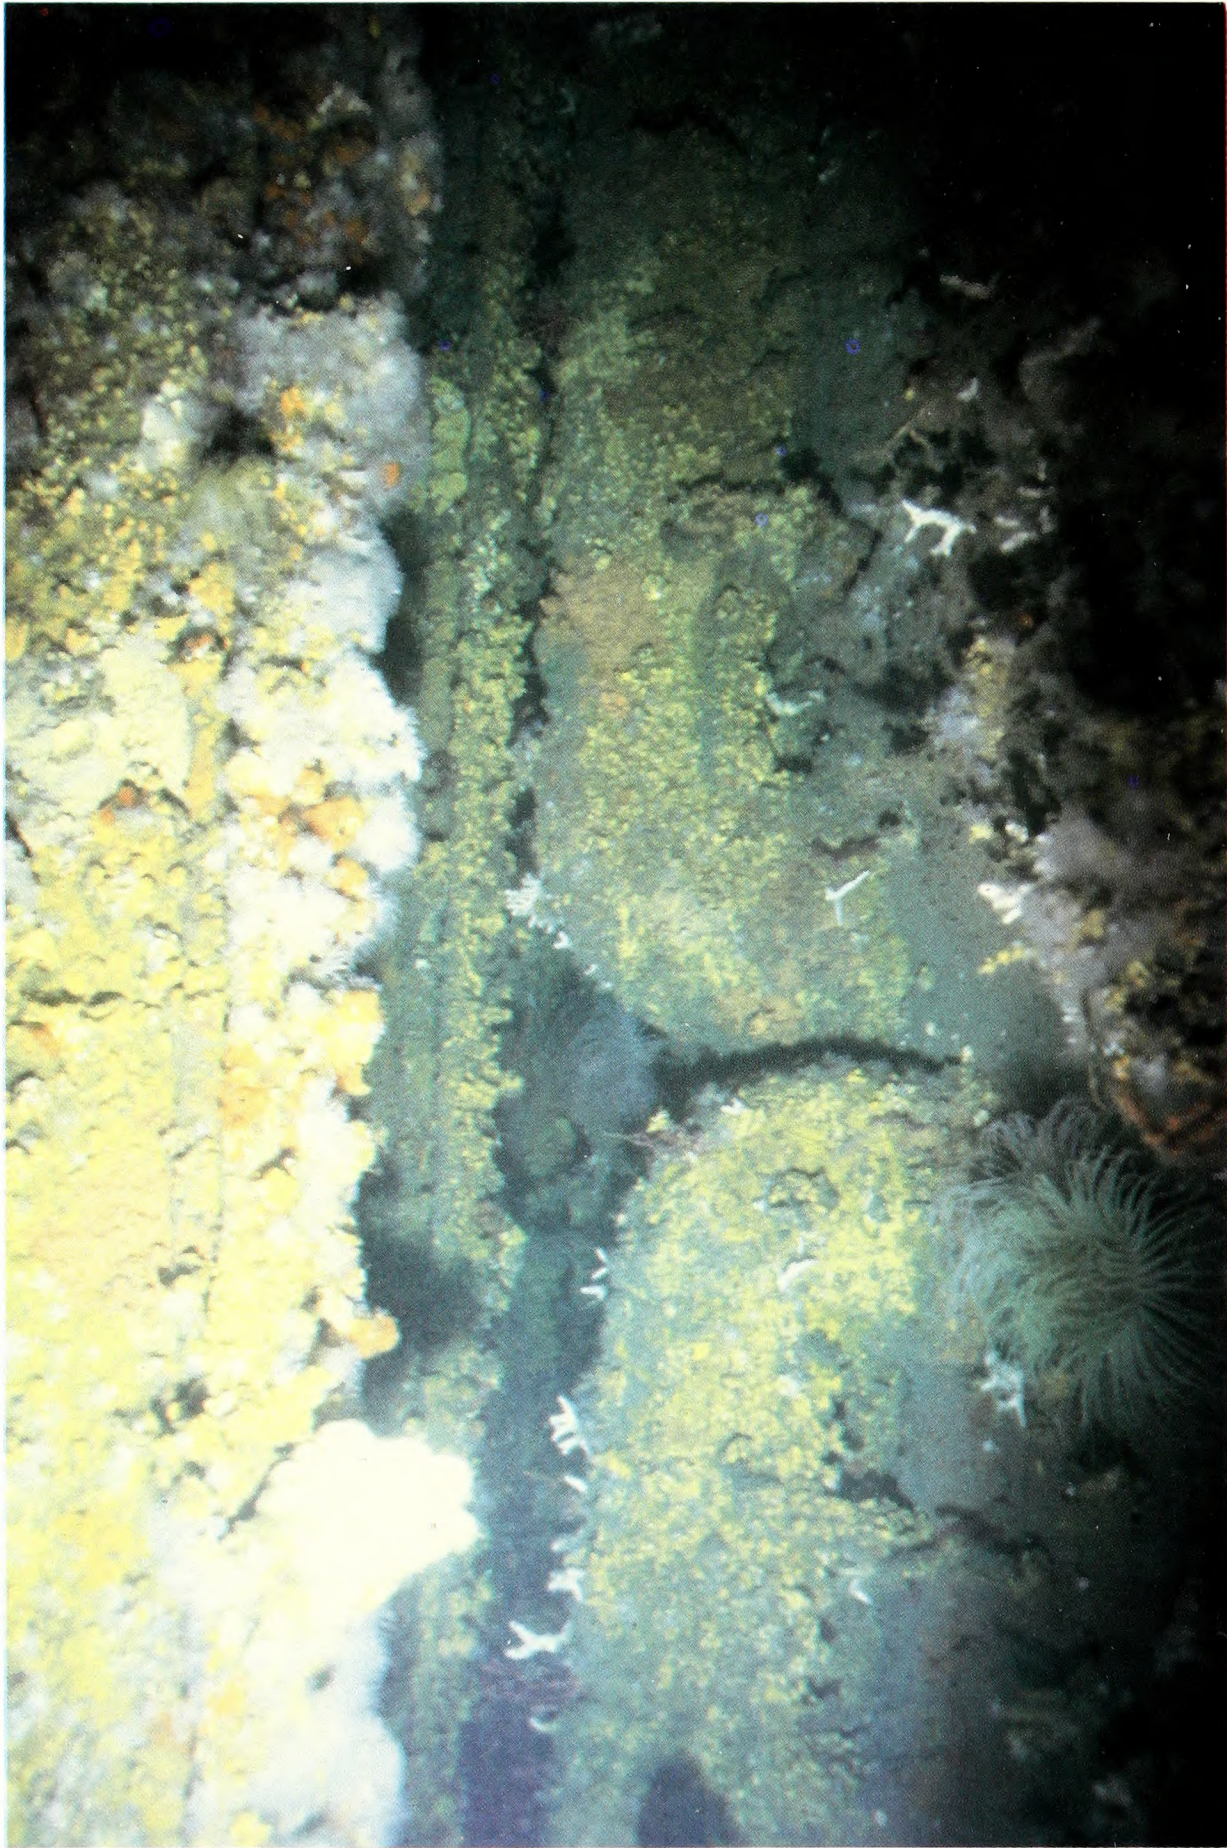
Figure 138. Large diameter pipes vent from the bottom of the boiler near their approximate center and run both inboard and outboard below the floors of the lower hull.

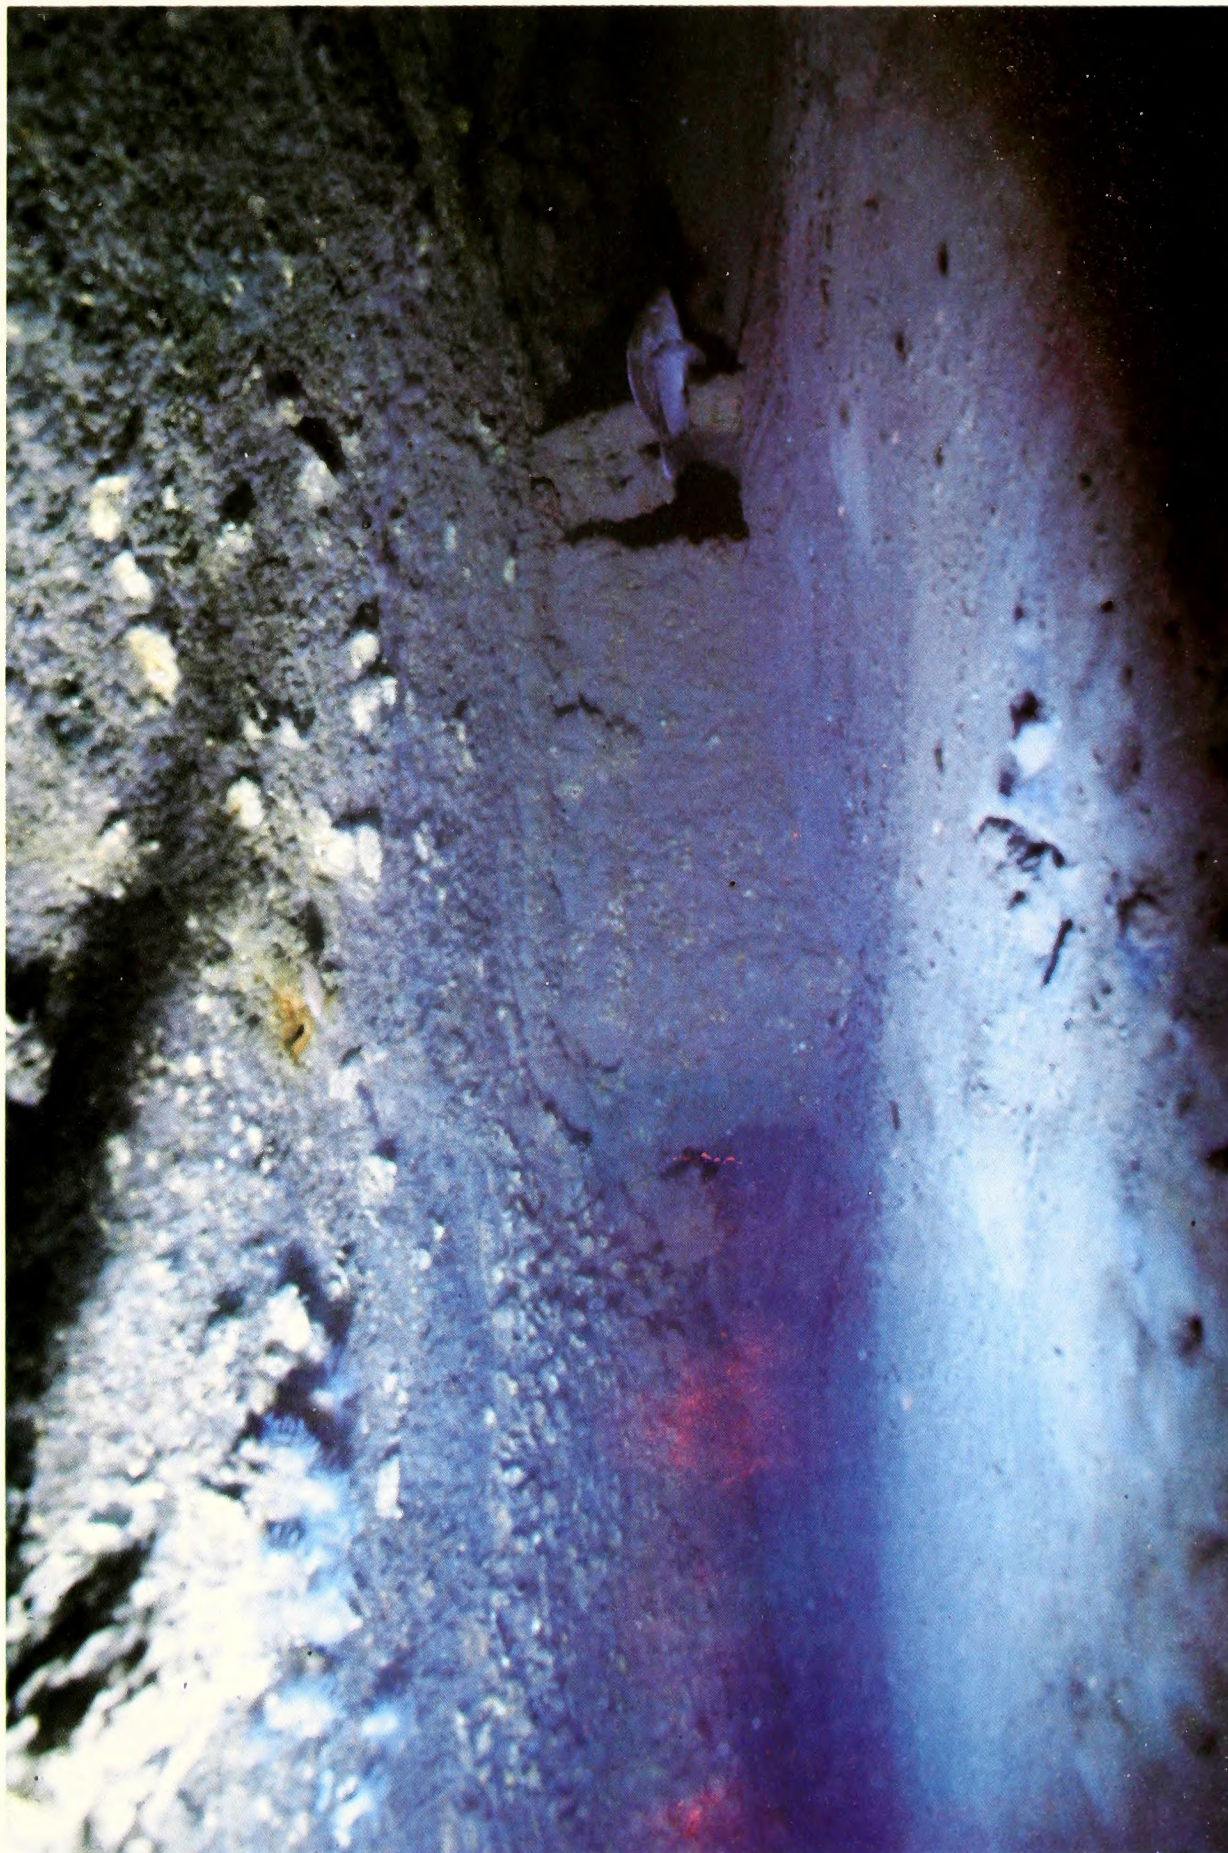
Figure 139. Forward of the turret, the port exhaust stack was exposed and intact at the base. Armor plating on the deck of the Monitor survives intact although considerable damage and deterioration were observed elsewhere.
